# LISTing Newsletter

Newseltr of the Long Island Sinclair/TimeX Users Group  
(Incorporating N.Y.T.S.E.)

MARCH 1992

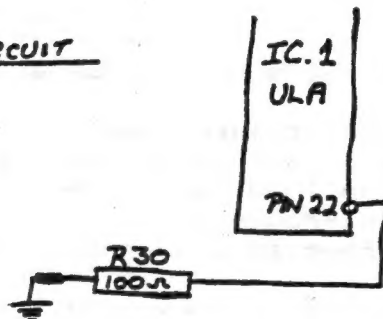
### ORIGINAL CIRCUIT

## TURBO/NORMAL SWITCH MODIFICATION FOR TS1000.

The whole idea of experimenting with a "Turbo Switch" came from reading the book "Explorer's Guide to the T/S1000" by Mike Lord. On page 58 of this book under the heading "Keyboard Scanning" he tells how the system variable MARGIN may be changed from 55 to 31 by taking pin 22 of the ULA chip HIGH or LOW. This is supposed to be of use to the computer manufacturer to enable the 1000 to be used in either the USA which uses 31 blank lines at the top and bottom of the screen, or in the UK which uses 55 blank lines. The book also states on page 53 under the heading "NMI Handler" that "When in the SLOW mode the ZX81 uses the time occupied by these blank lines to carry on with your program."

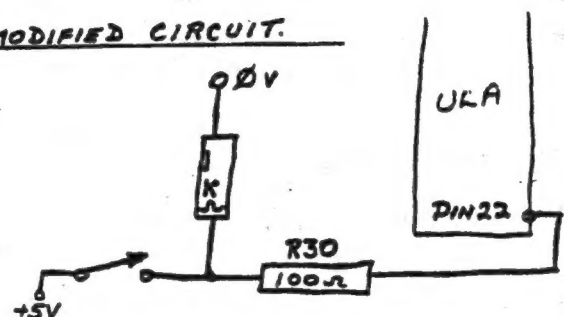
### MODIFIED CIRCUIT.

- 1 x SP/ST SWITCH
- 1 x 1K 1/4W RESISTOR
- 1 x RIBBON CABLE (6" LONG)
